Rocky Flats Environmental Technology Site  
Golden, Colorado

**Rocky Flats Environmental Technology Site**  
**Golden, Colorado**  
**INTEGRATING CONTRACTOR, KAISER-HILL L.L.C.**

**Demolition, Decontamination and  
Decommissioning (D&D) Projects,  
Deactivation Projects,  
and Remediation Projects  
In-Progress, Planned, or Completed  
for the  
Rocky Flats Environmental Technology Site**

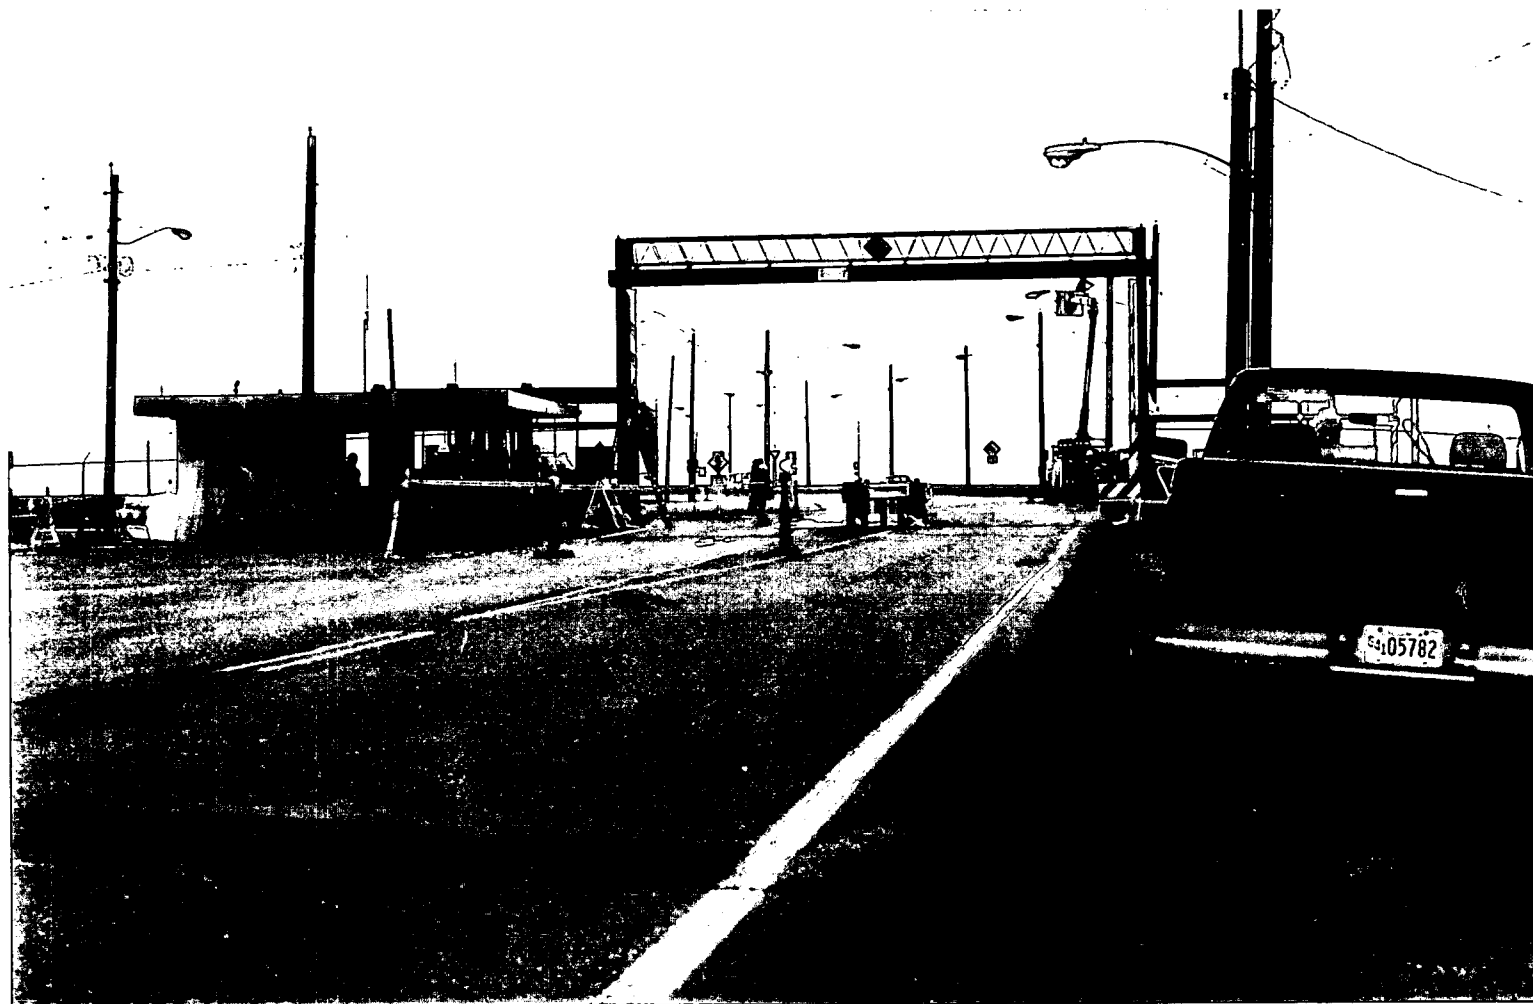
**Figure 15:** (before) Looking east at Building 900. Note bullet proof glass against building. Electrical feeds have been locked out tagged out and grounded (grounds visible on left side of photo).

Note lineman working from bucket truck behind gate. Personnel in building are removing remaining equipment in preparation for demolition activities beginning June 30, 1995, in afternoon.

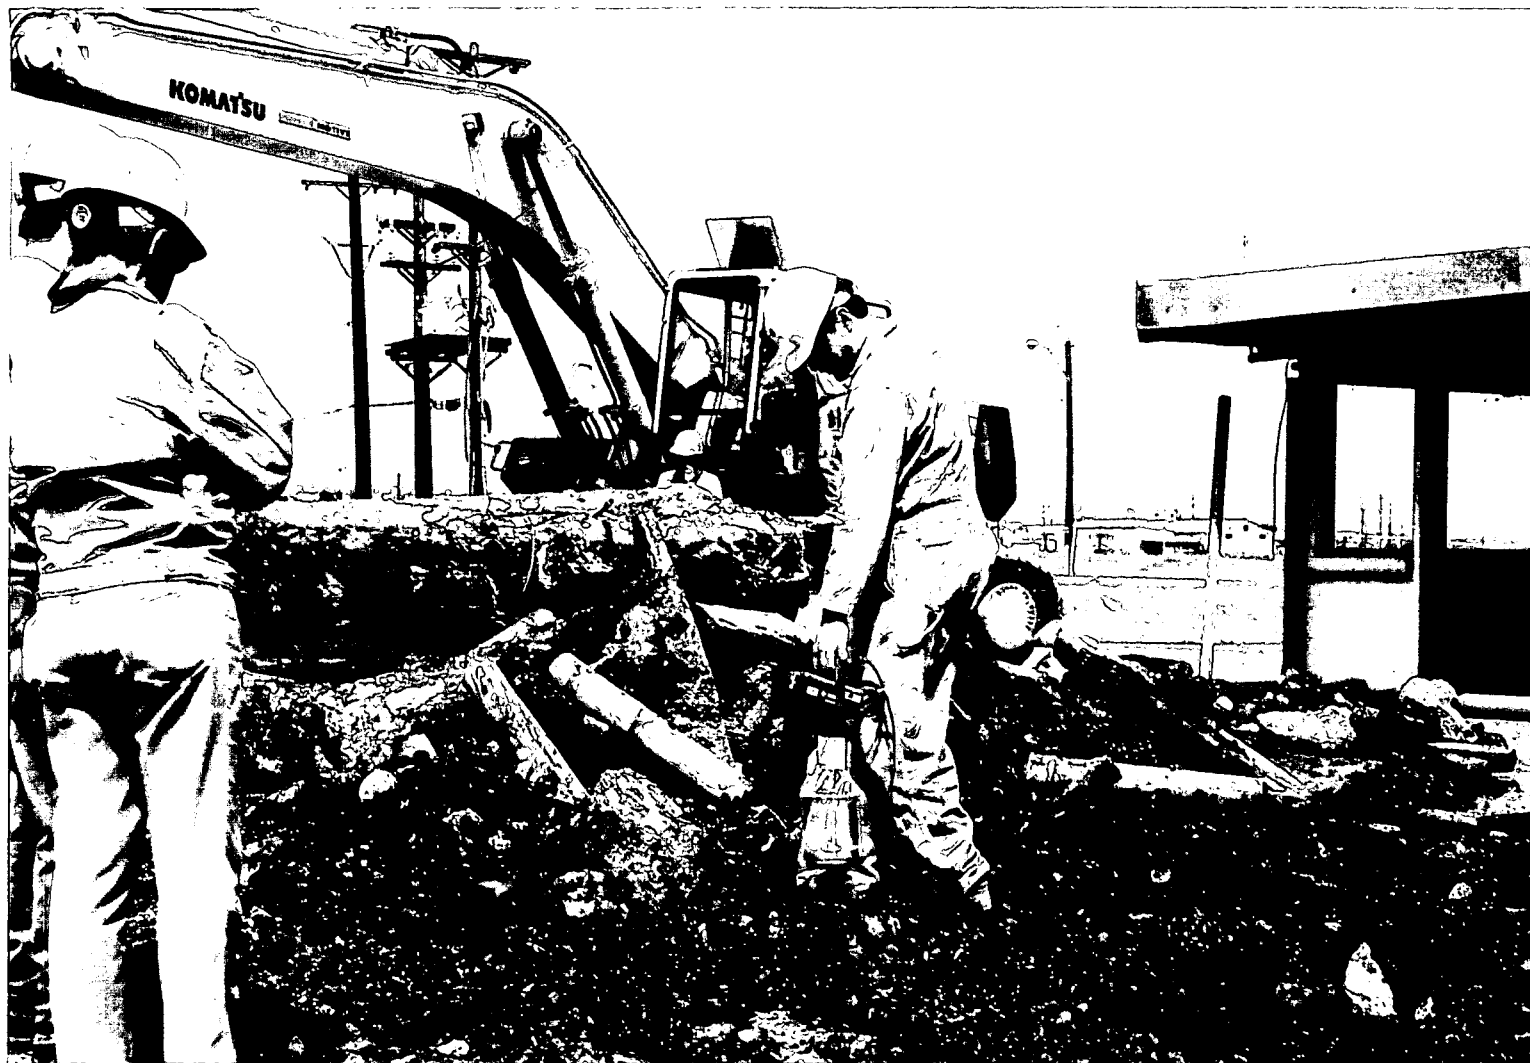
**Figure 16:** (during) Looking west at Guardpost 900. Radiological Control Technician uses instrument ("fiddler") "Field Instrument Detector for Low Energy Radiation," to check soil disturbed from slab excavation (no findings). Komatsu tracked excavator in background.

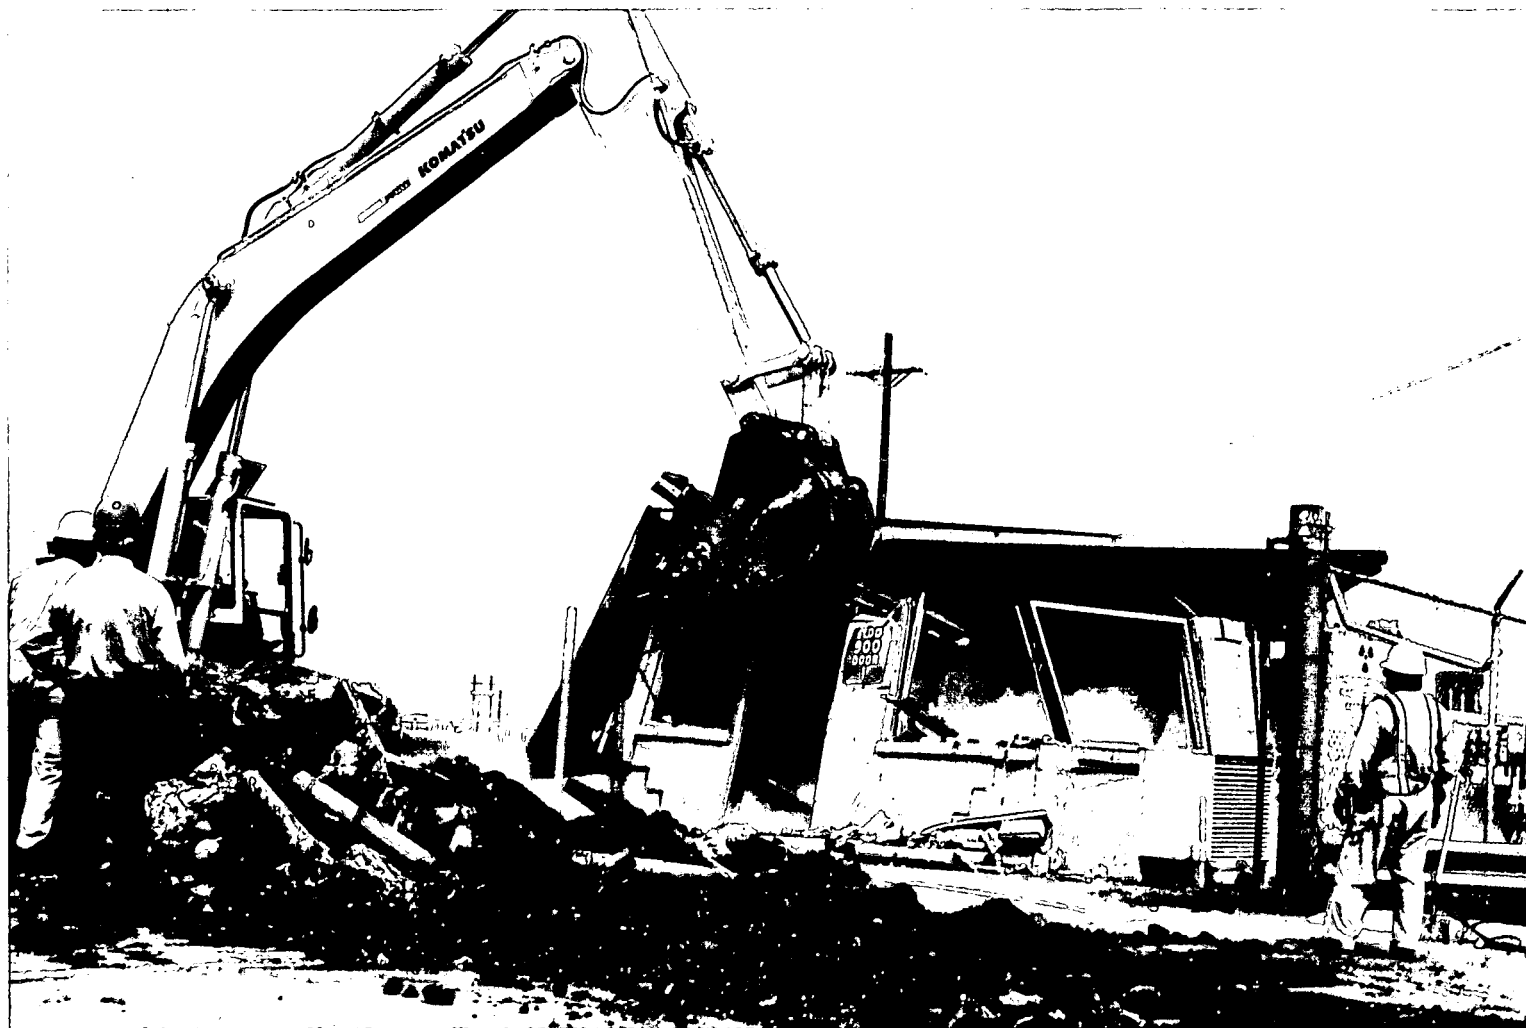
**Figure 17:** (during) Pictures taken minutes after Radiological clearance is given. Building is demolished and rubble loaded into 10 yard dump trucks for transport to onsite sanitary landfill. Note: Concrete rubble was recycled as erosion control rip rap on edge of landfill. Metal, structural was separated by excavator and placed into brown container (visible on right) for recycling.

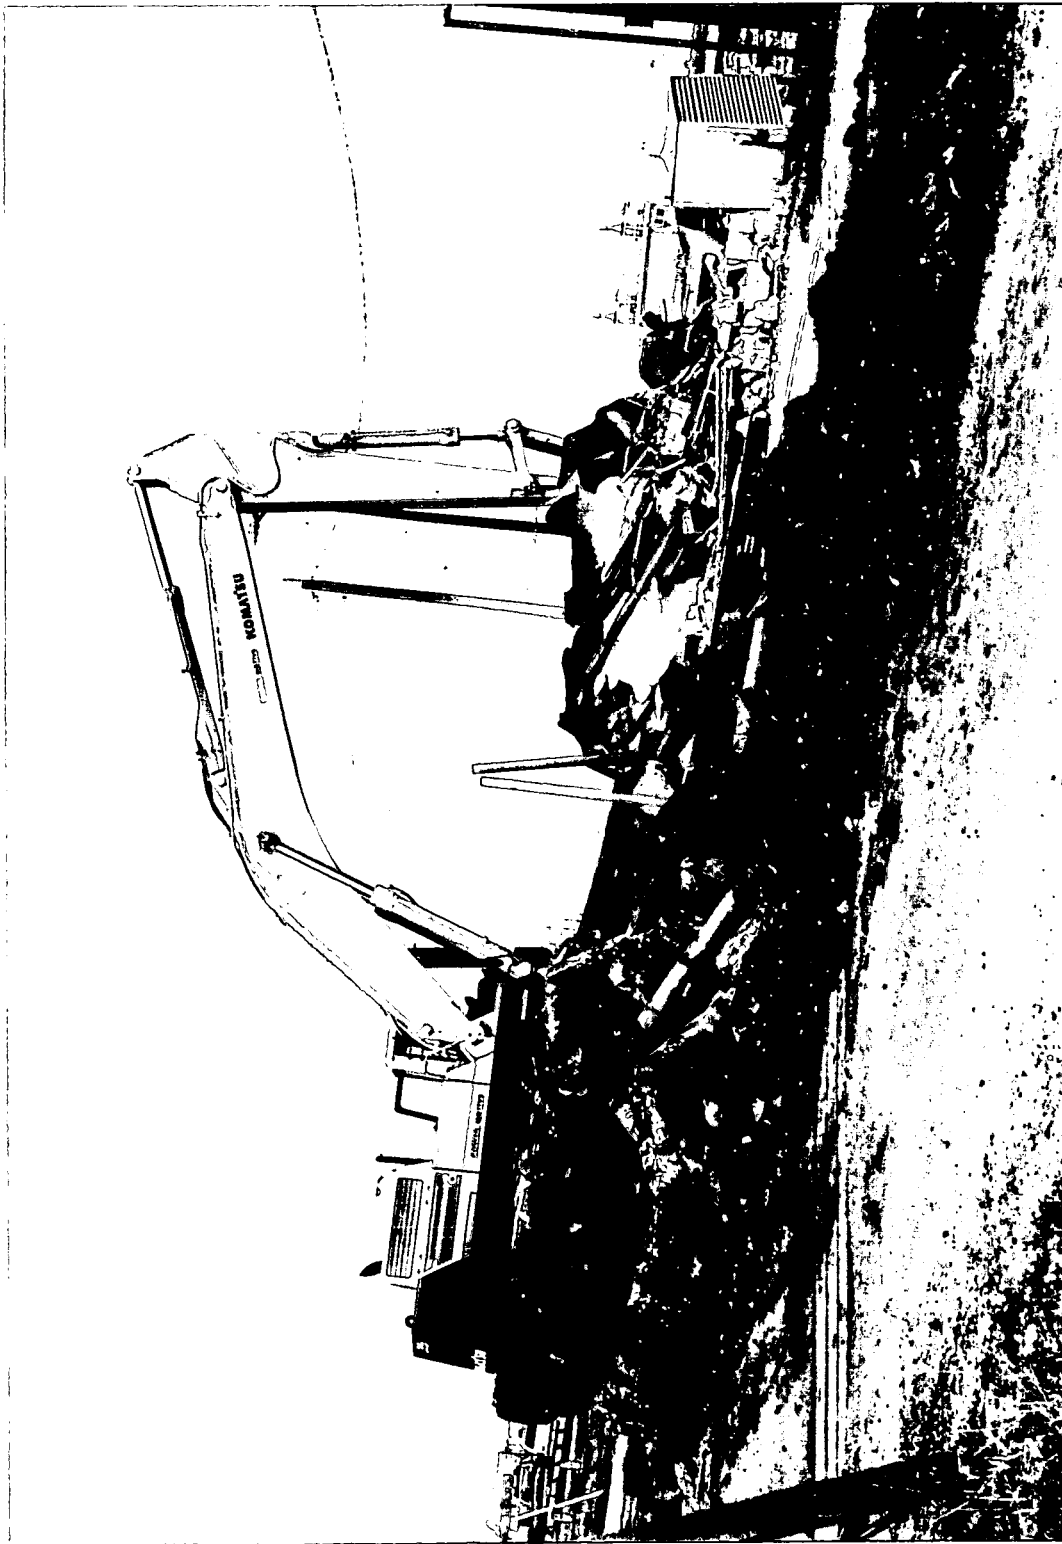
Figure 18: (during) Building is down. Separation and loading of remaining material proceeds.

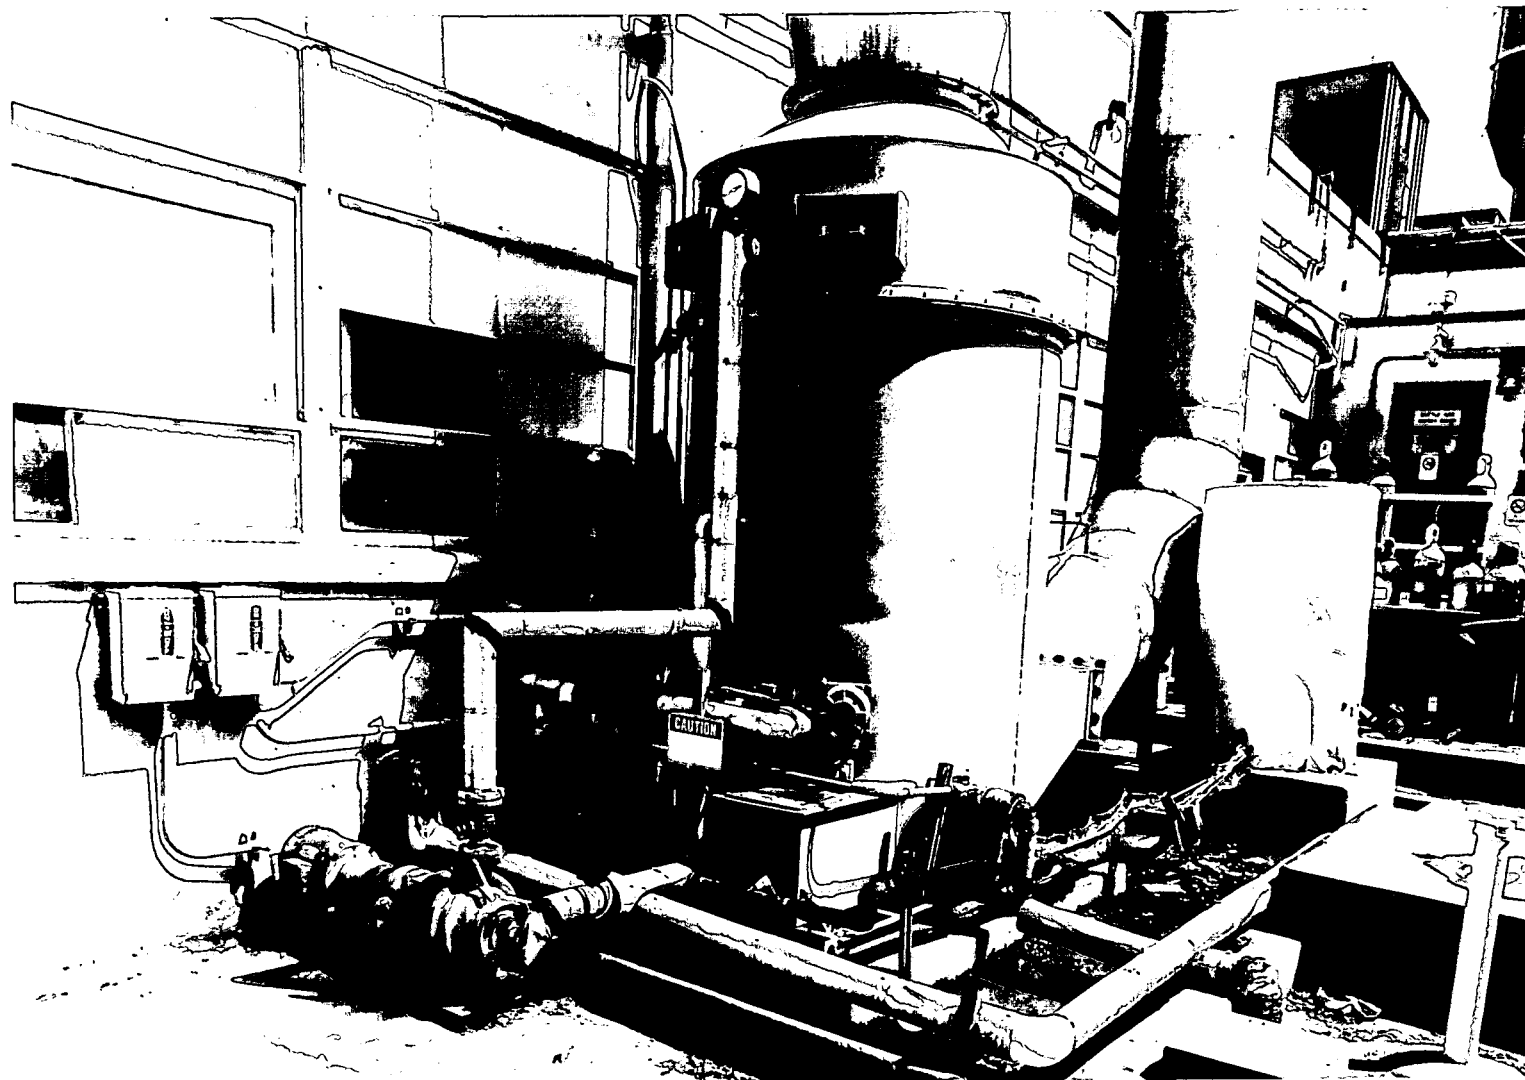
**Figure 19:** (before) View looking northwest. One tank and piping visible on right. Tanks were verified as “clean” per sampling results. Asbestos on the tanks was encapsulated. One tank was placed inside the other and packed for disposal.

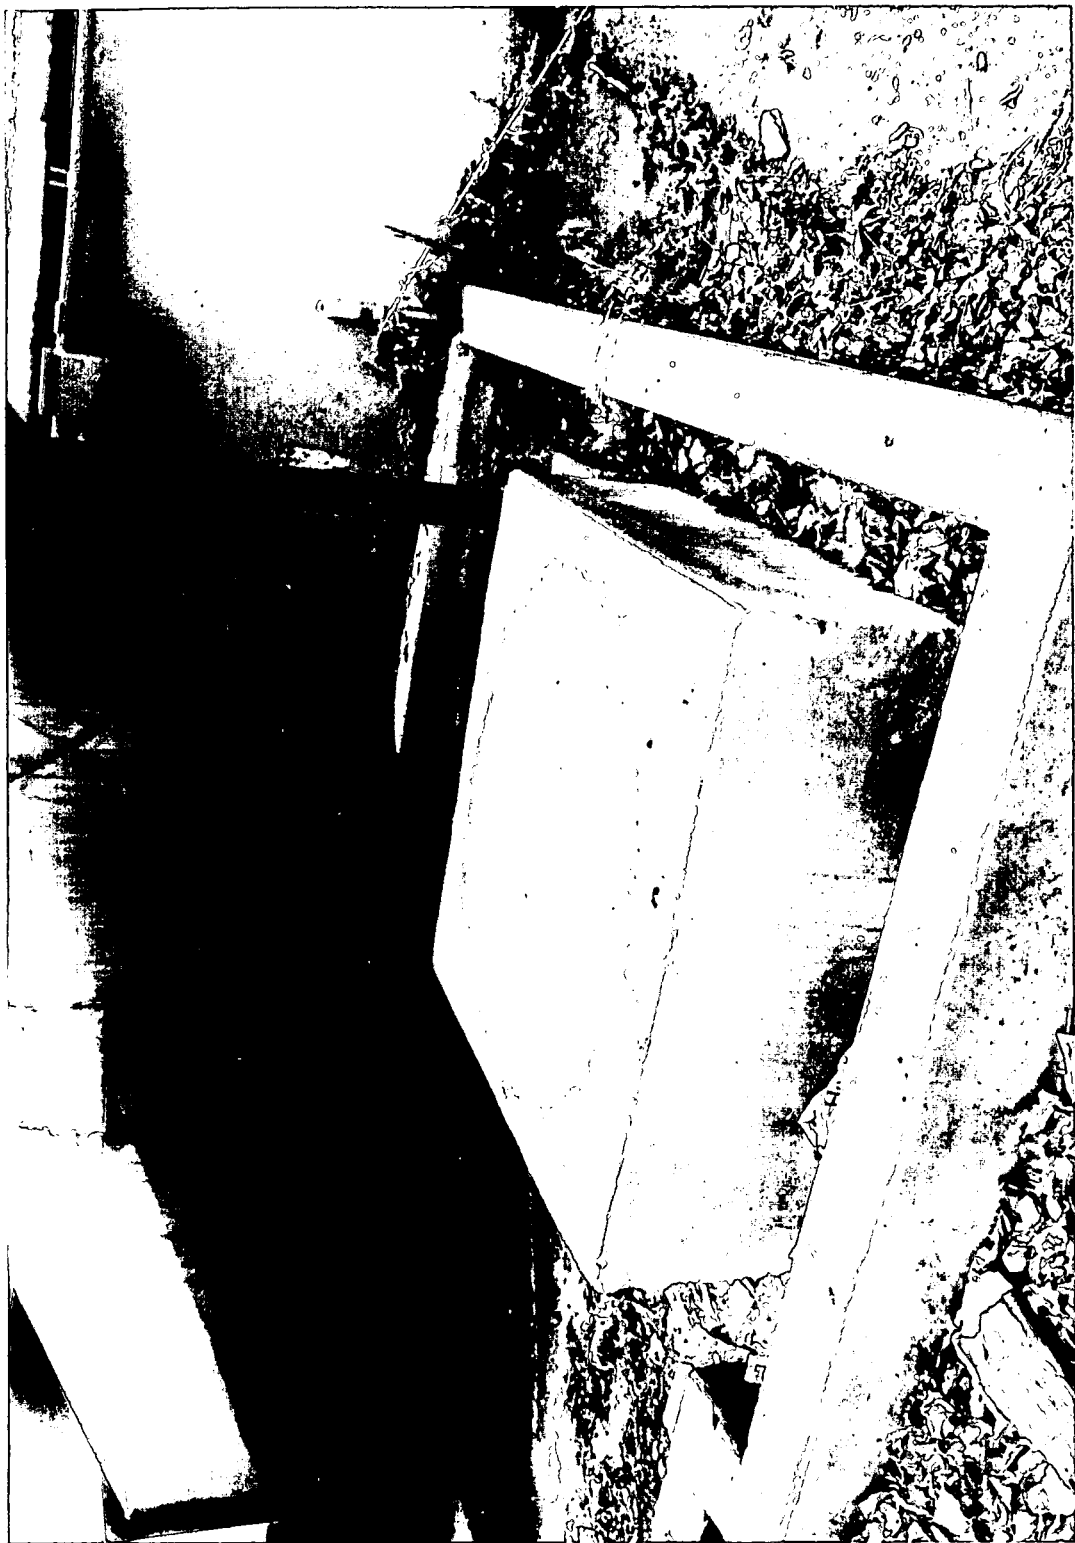
Figure 20: (after) View looking west at tanks pedestal.

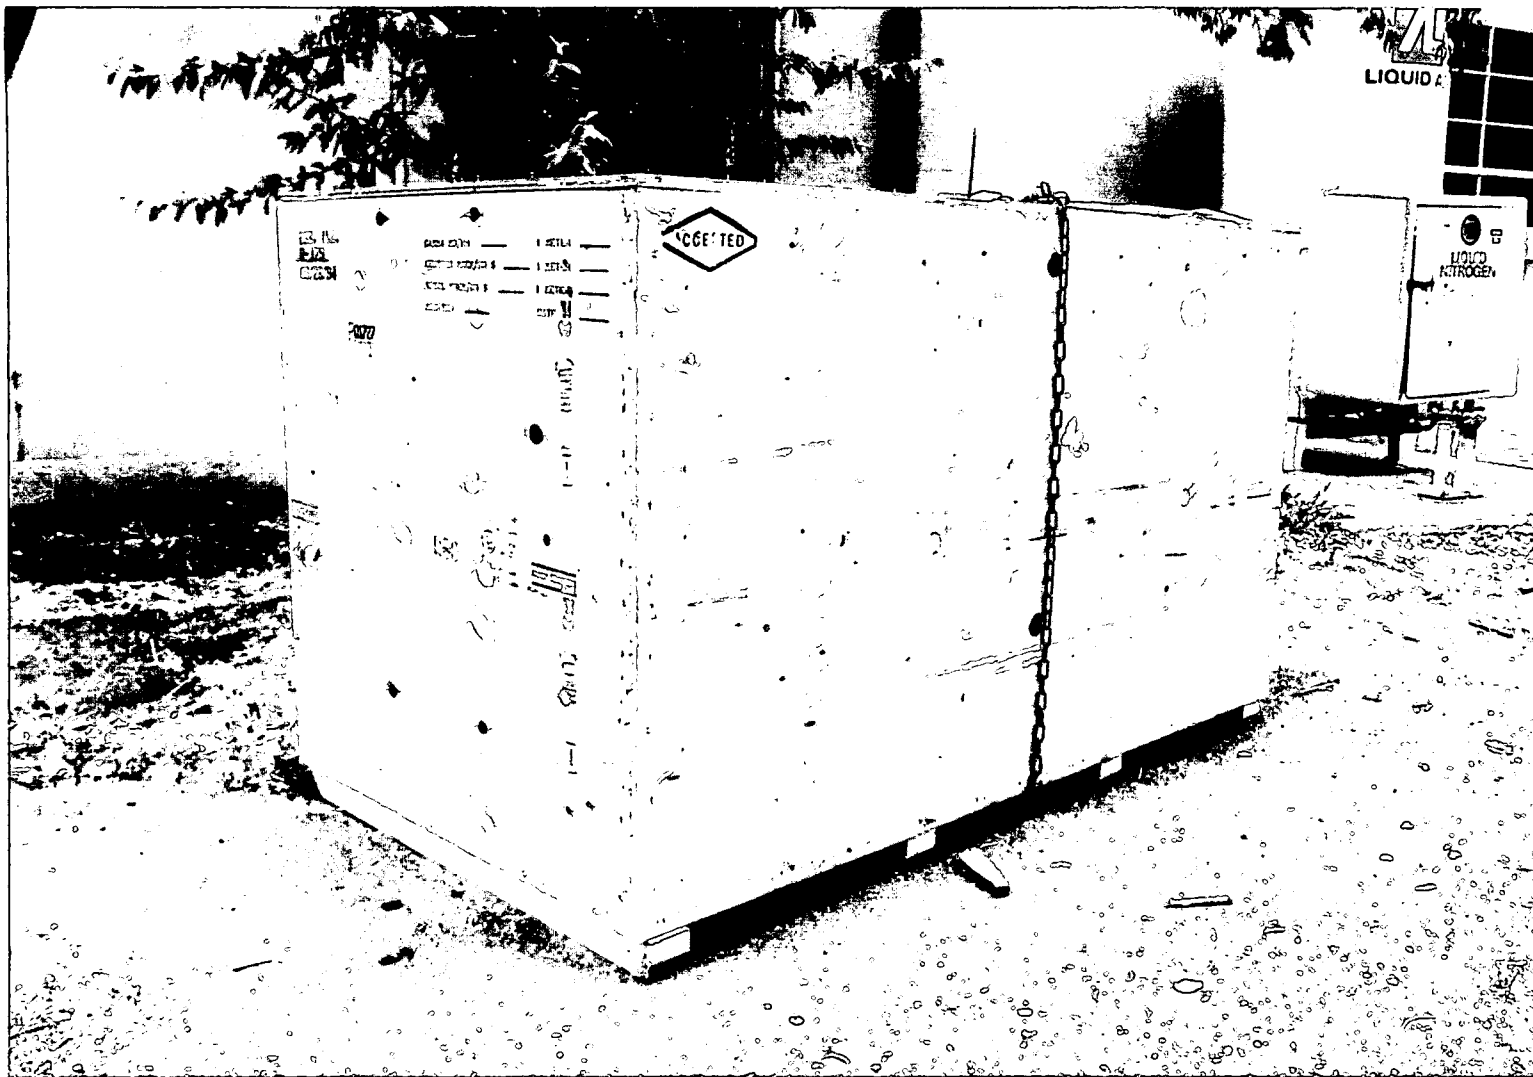
**Figure 21:** (after) Standard waste crate, 4' X 4' X 8' long, used to dispose of tanks.

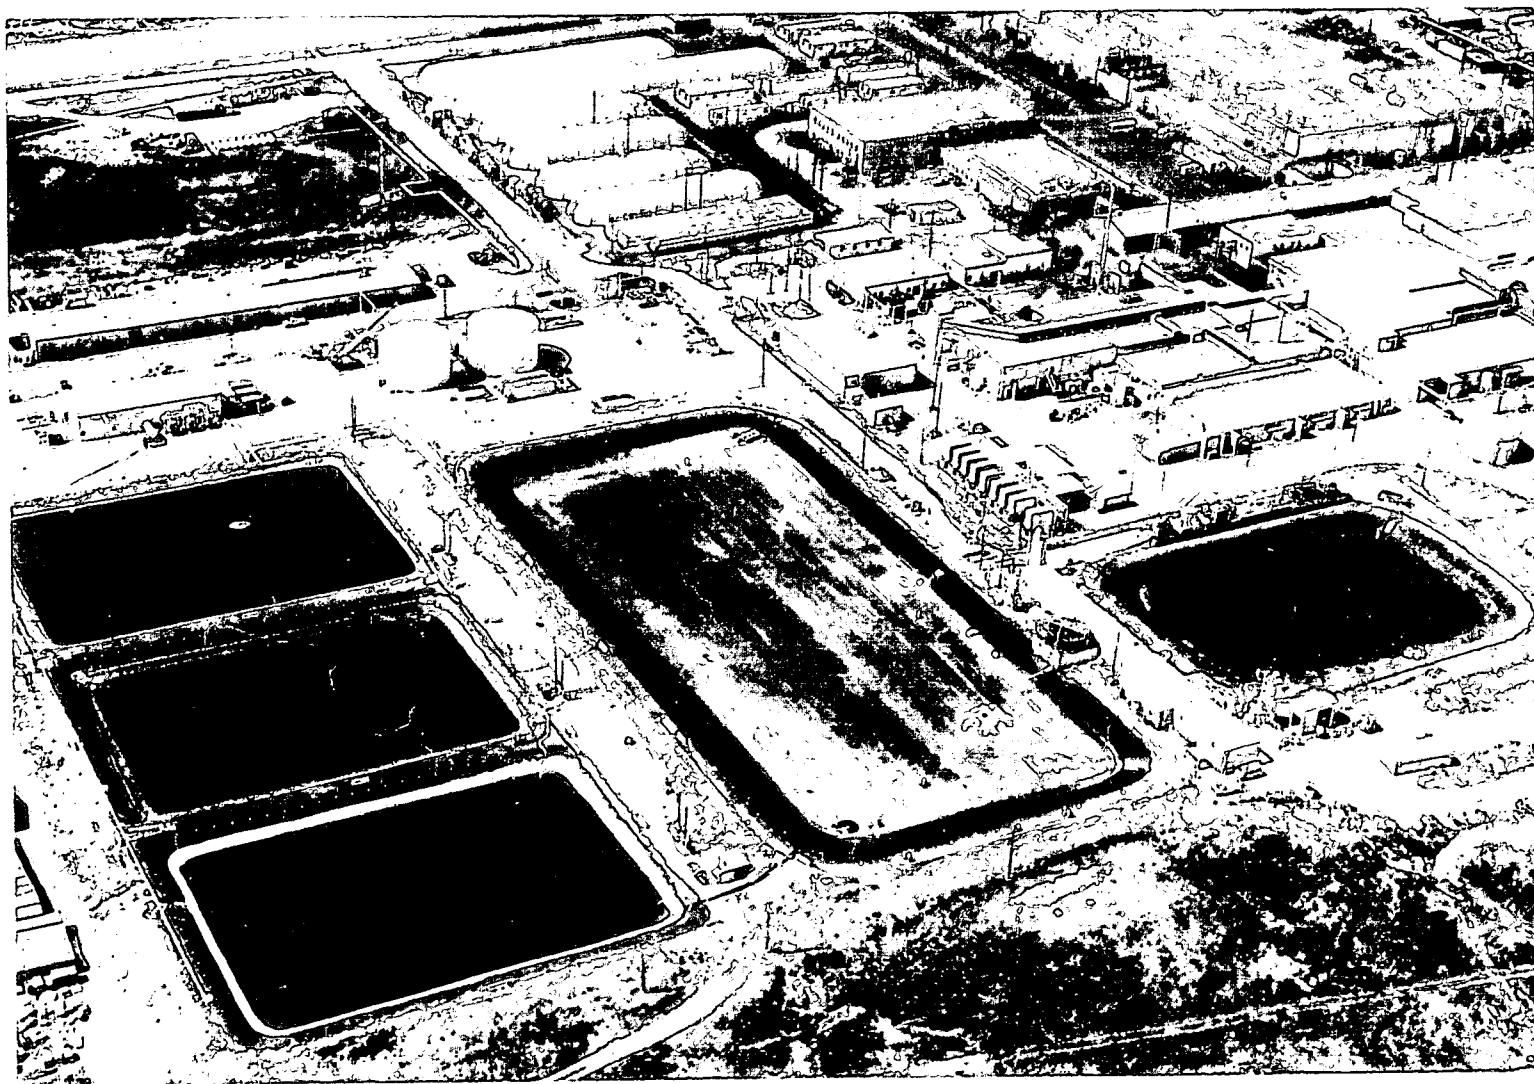
**Figure 22:** (before) Aerial view of the five ponds; 207A in middle, to the left (east), 207B (north, center, south), to the right (west), Pond 207C.

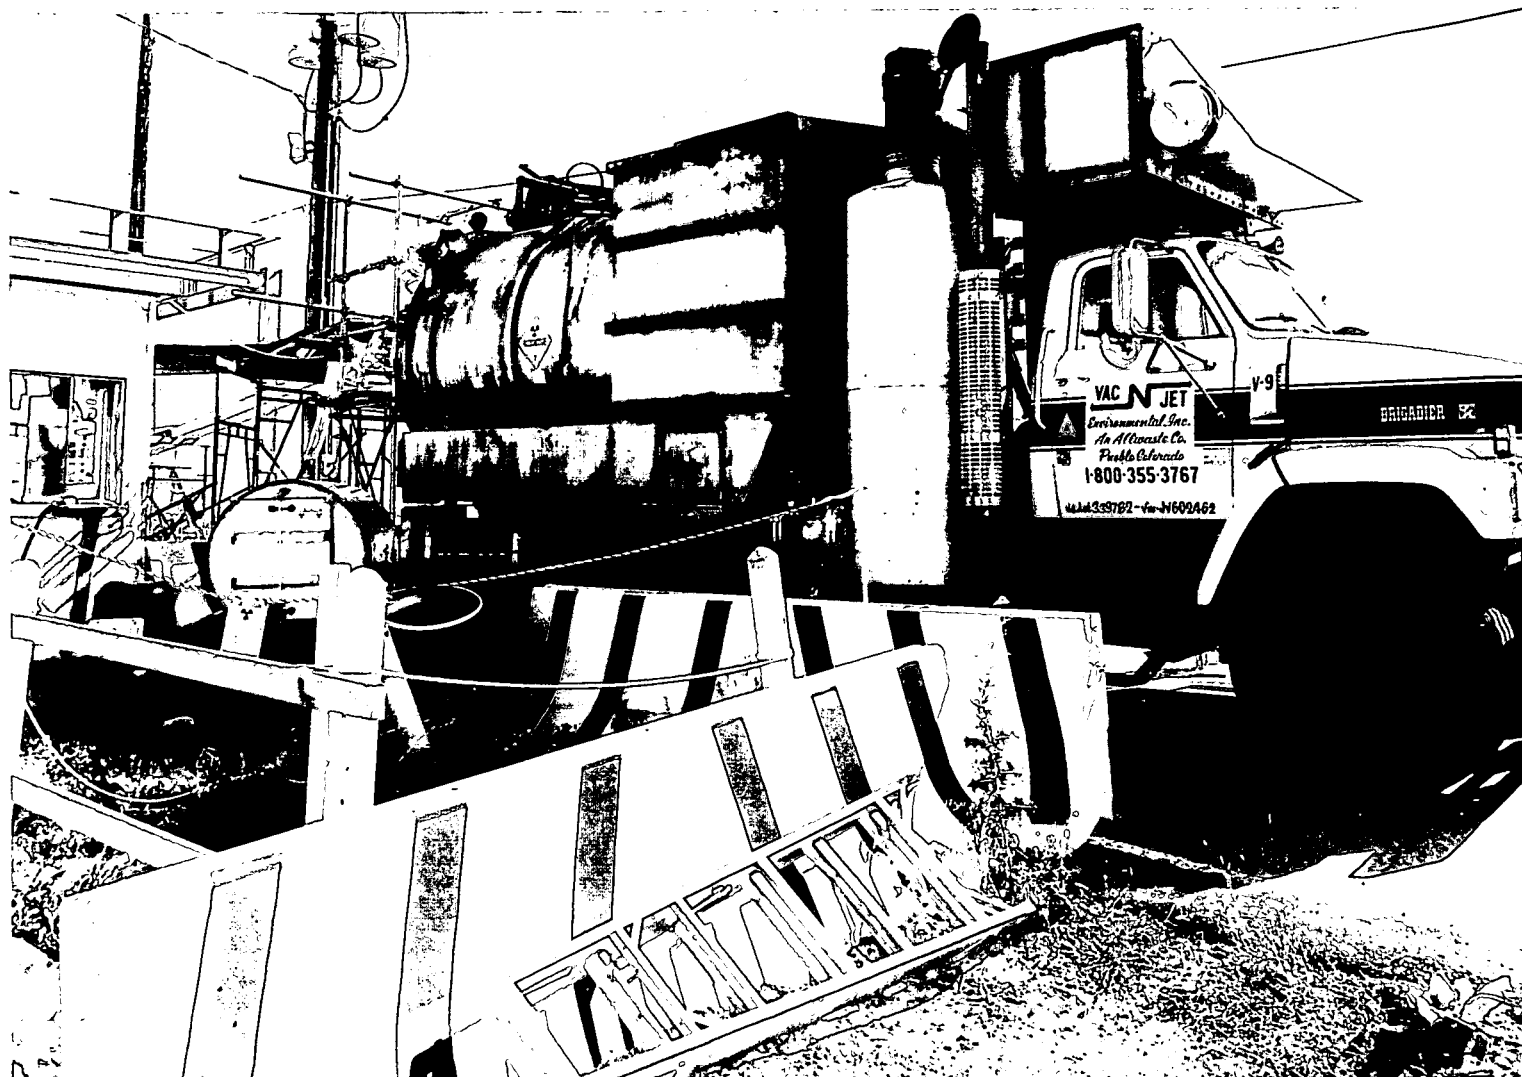
**Figure 23:** (during) Vacuum trucks were used to transport sludge from the solar evaporation ponds to 10,000 gallon storage tanks located at the 750 pad tent structures.

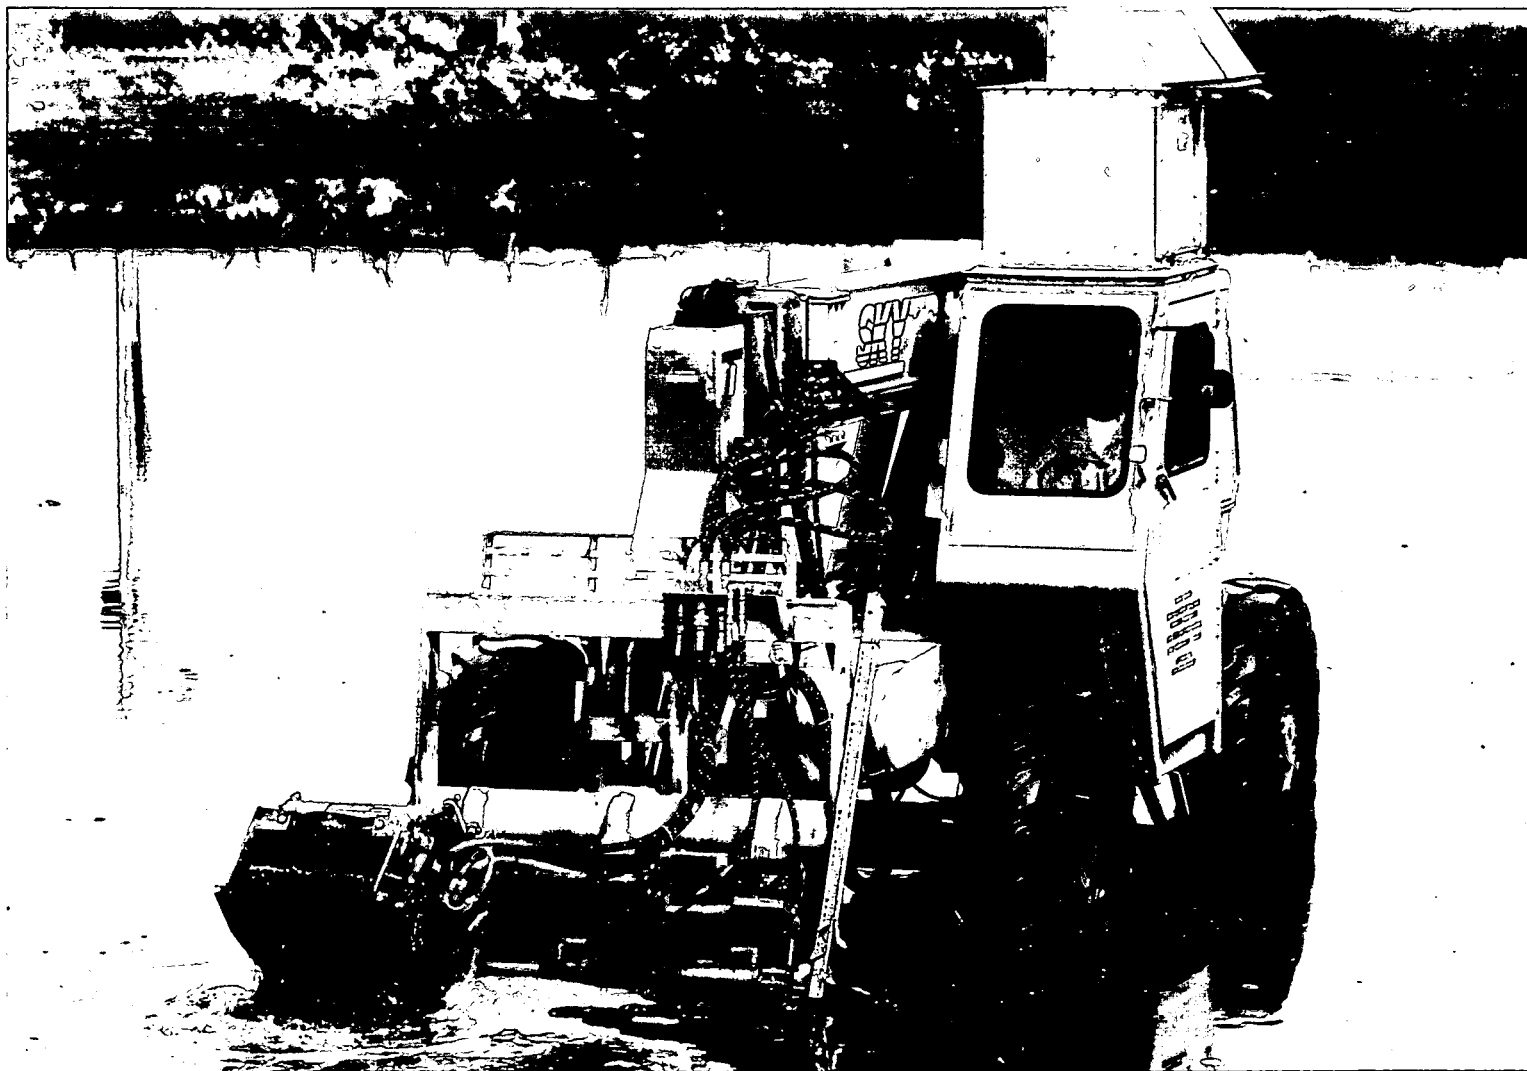
**Figure 24:** (during) “Saltbuster” (a four wheel drive vehicle) with rotomiller attachment was used to “slurry” sludge.

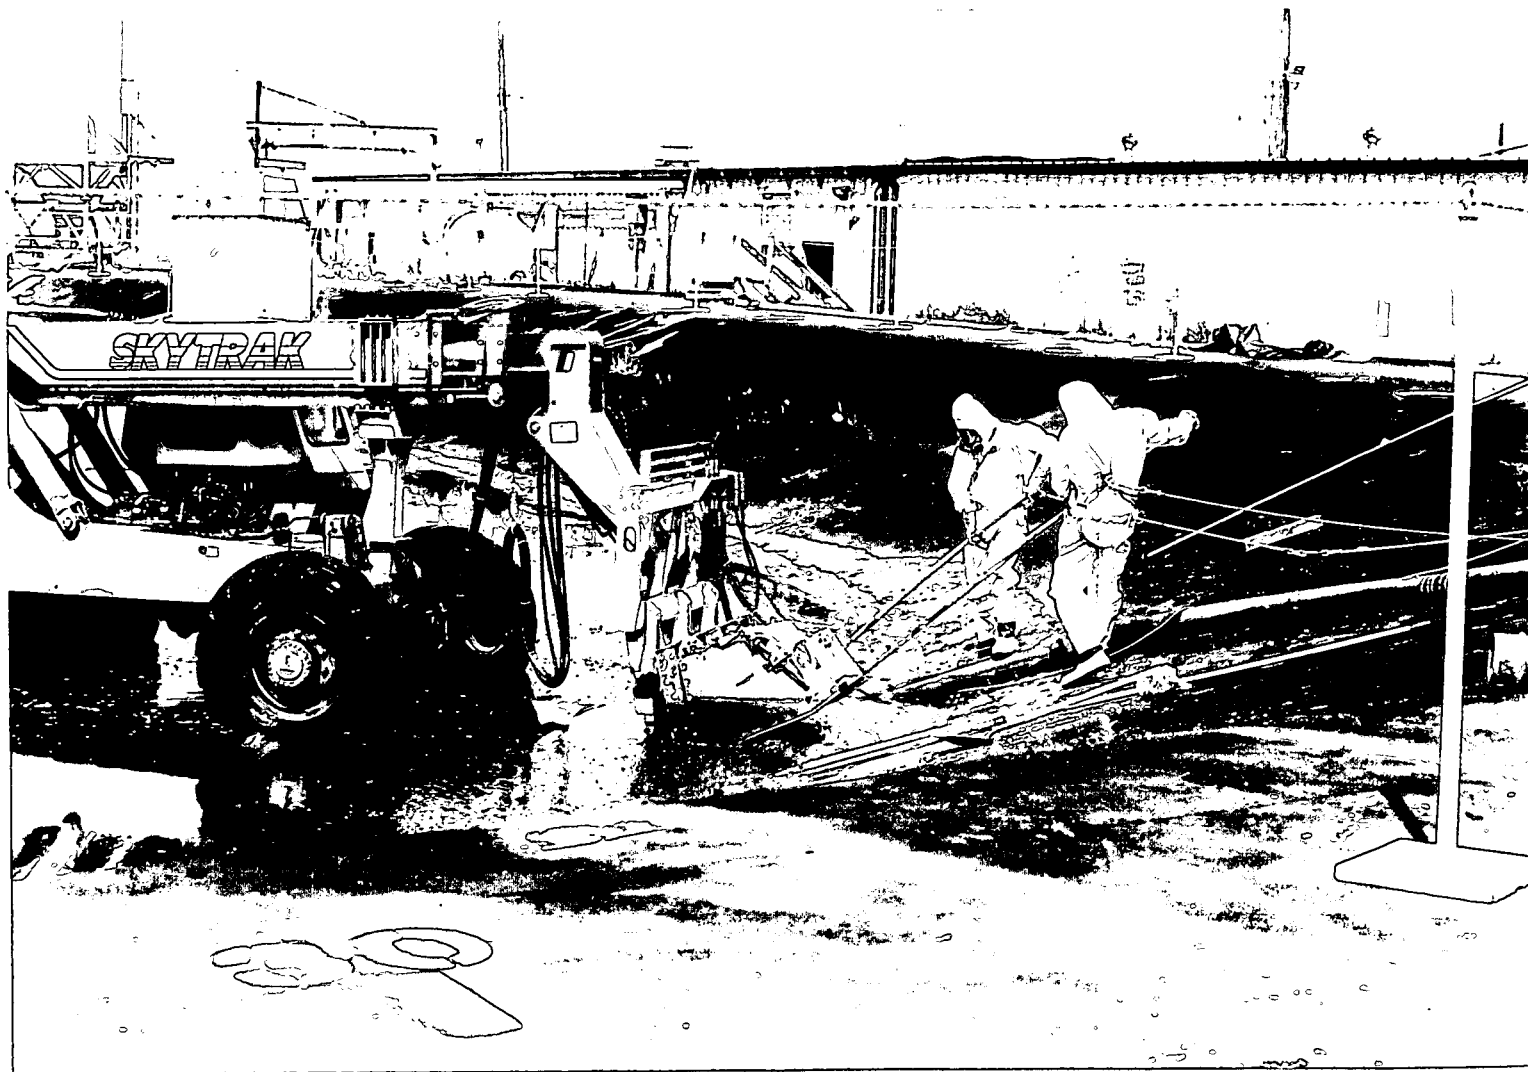
**Figure 25:** (during) Saltbuster pushed sludge material toward vacuum nozzle to be conveyed through over-land transfer hose to vacuum truck.

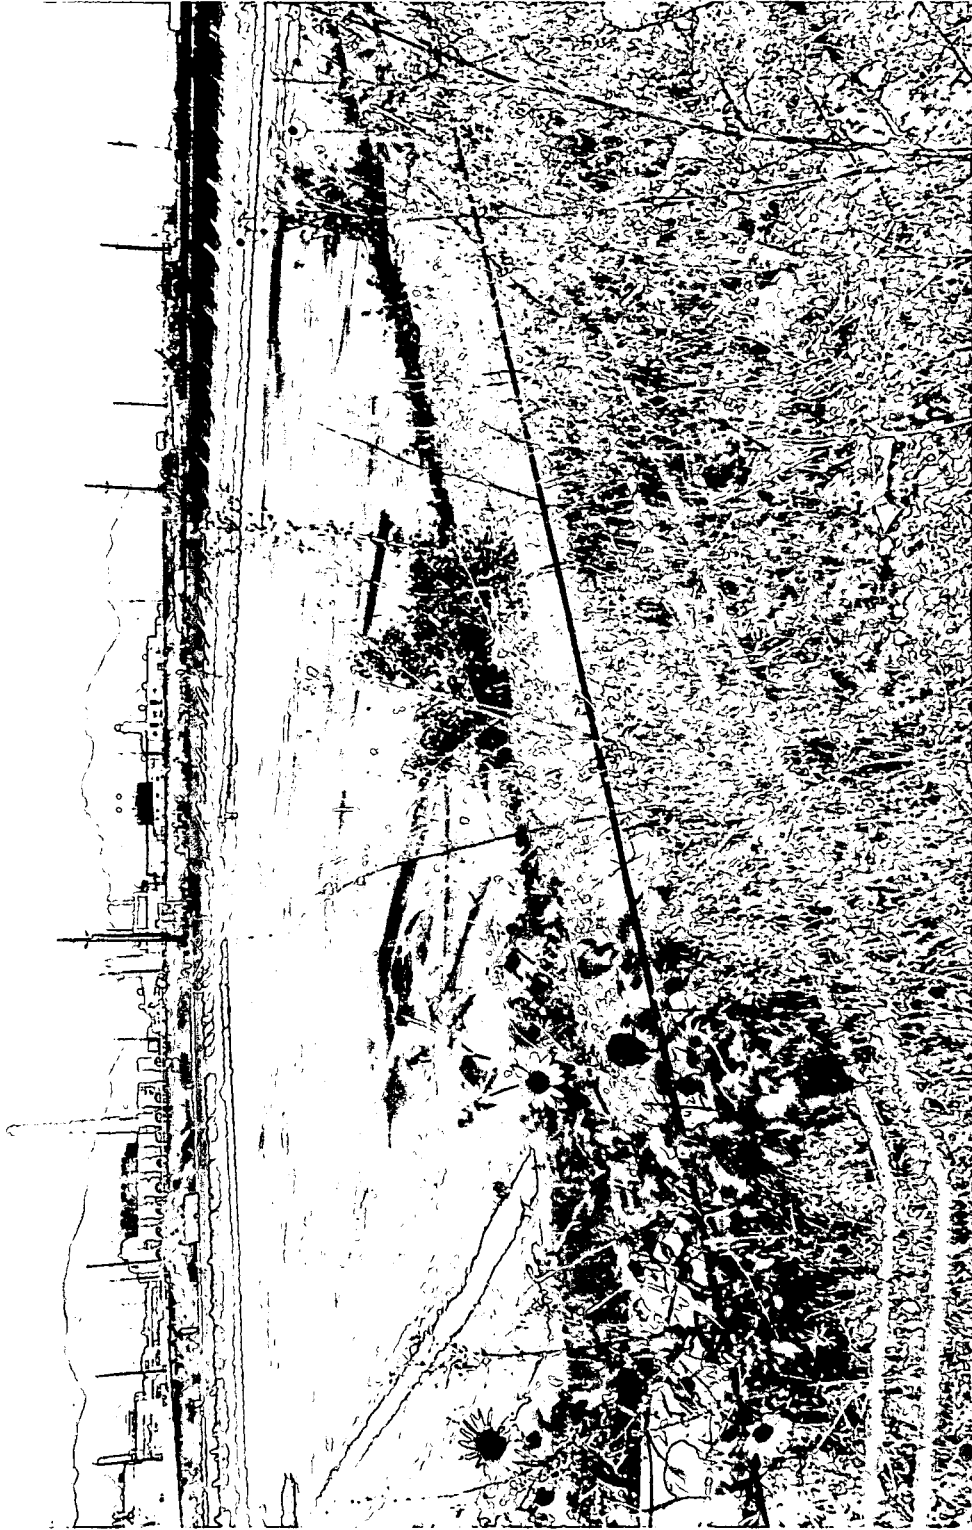
**Figure 26:** (after) Depicts Pond 207B south pond after sludge removal activities were completed. Picture shows synthetic liner with perimeter ballast sandbags as a hold-down for liner.

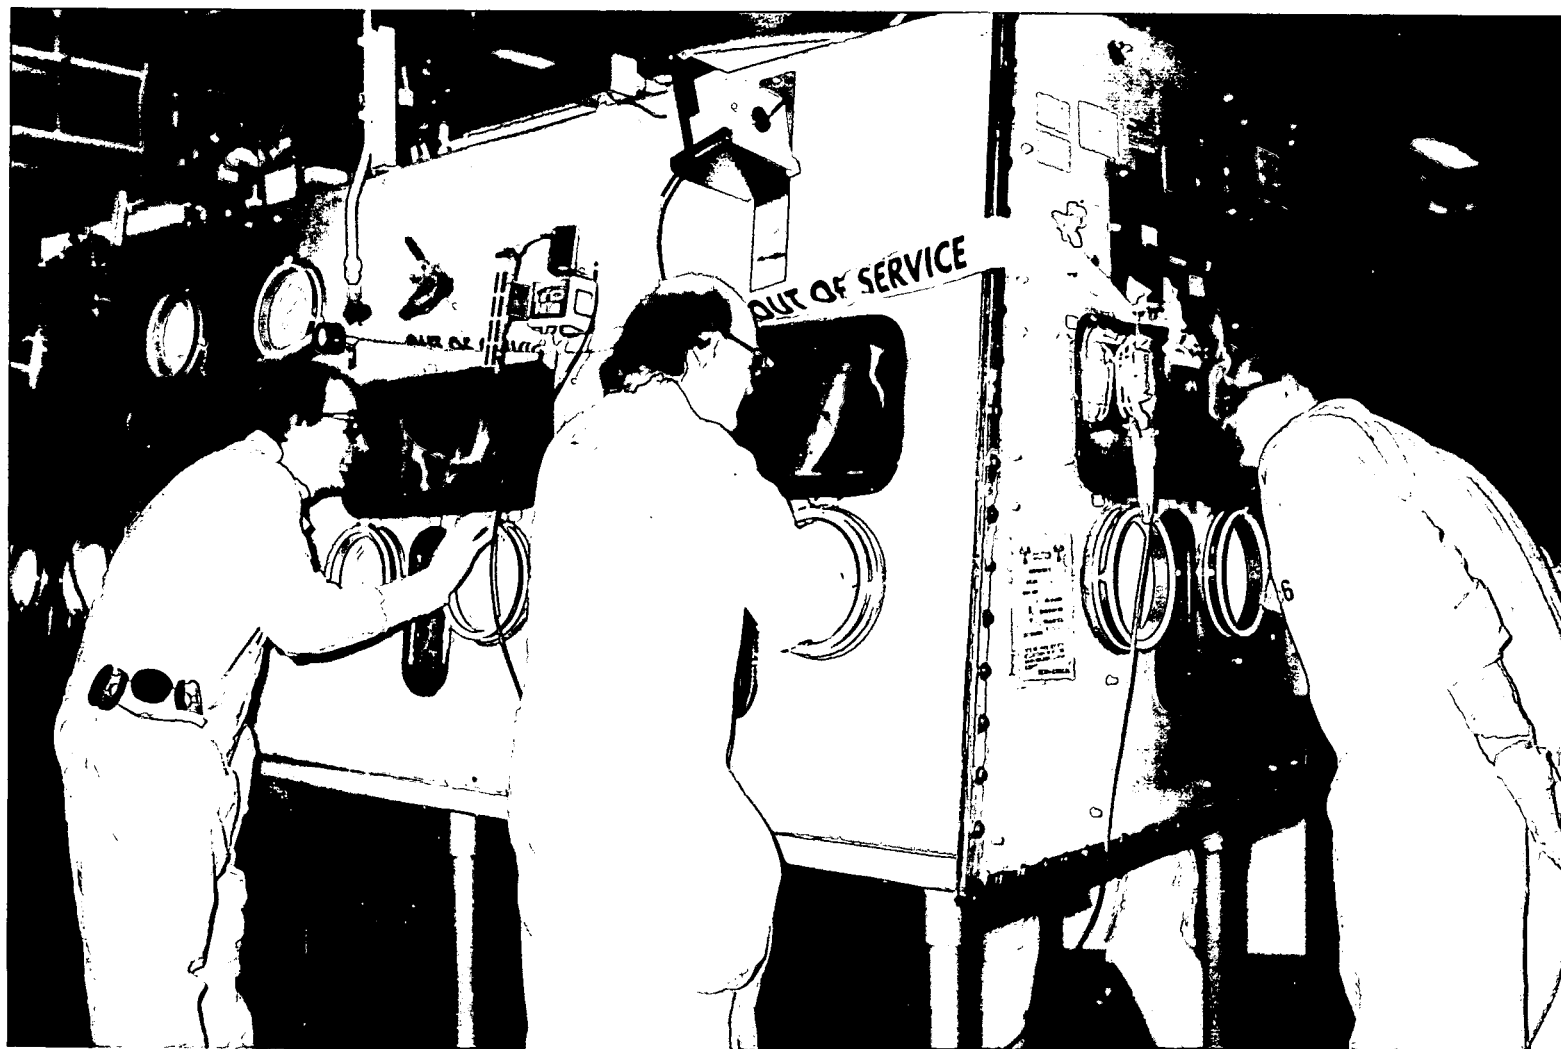
**Figure 29:** (during/after) Workers removing stripcoat. Significant amounts of material (powder and grease) were removed from crevices behind window frames, gasketed joints and the intricate geometry of the equipment inside of the glovebox. Removal of TLC resulted in long rope like pieces that could not be pulled apart by hand.
